THE COMMISSION OF INQUIRY

APPOINTED TO INQUIRE INTO ALL THE CIRCUMSTANCES IN WHICH A FOREIGN AIRCRAFT ENTERED INTO THE TERRITORY OF THE CO-OPERATIVE REPUBLIC OF GUYANA AND WAS DISCOVERED ON THE GROUND NEAR TO THE VILLAGE OF YUPUKARI, IN THE RUPUNUNI (UPPER ESSEQUIBO- UPPER TAKUTU) REGION 9.

VOLUME I: REPORT AND APPENDICES

25TH NOVEMBER, 2016

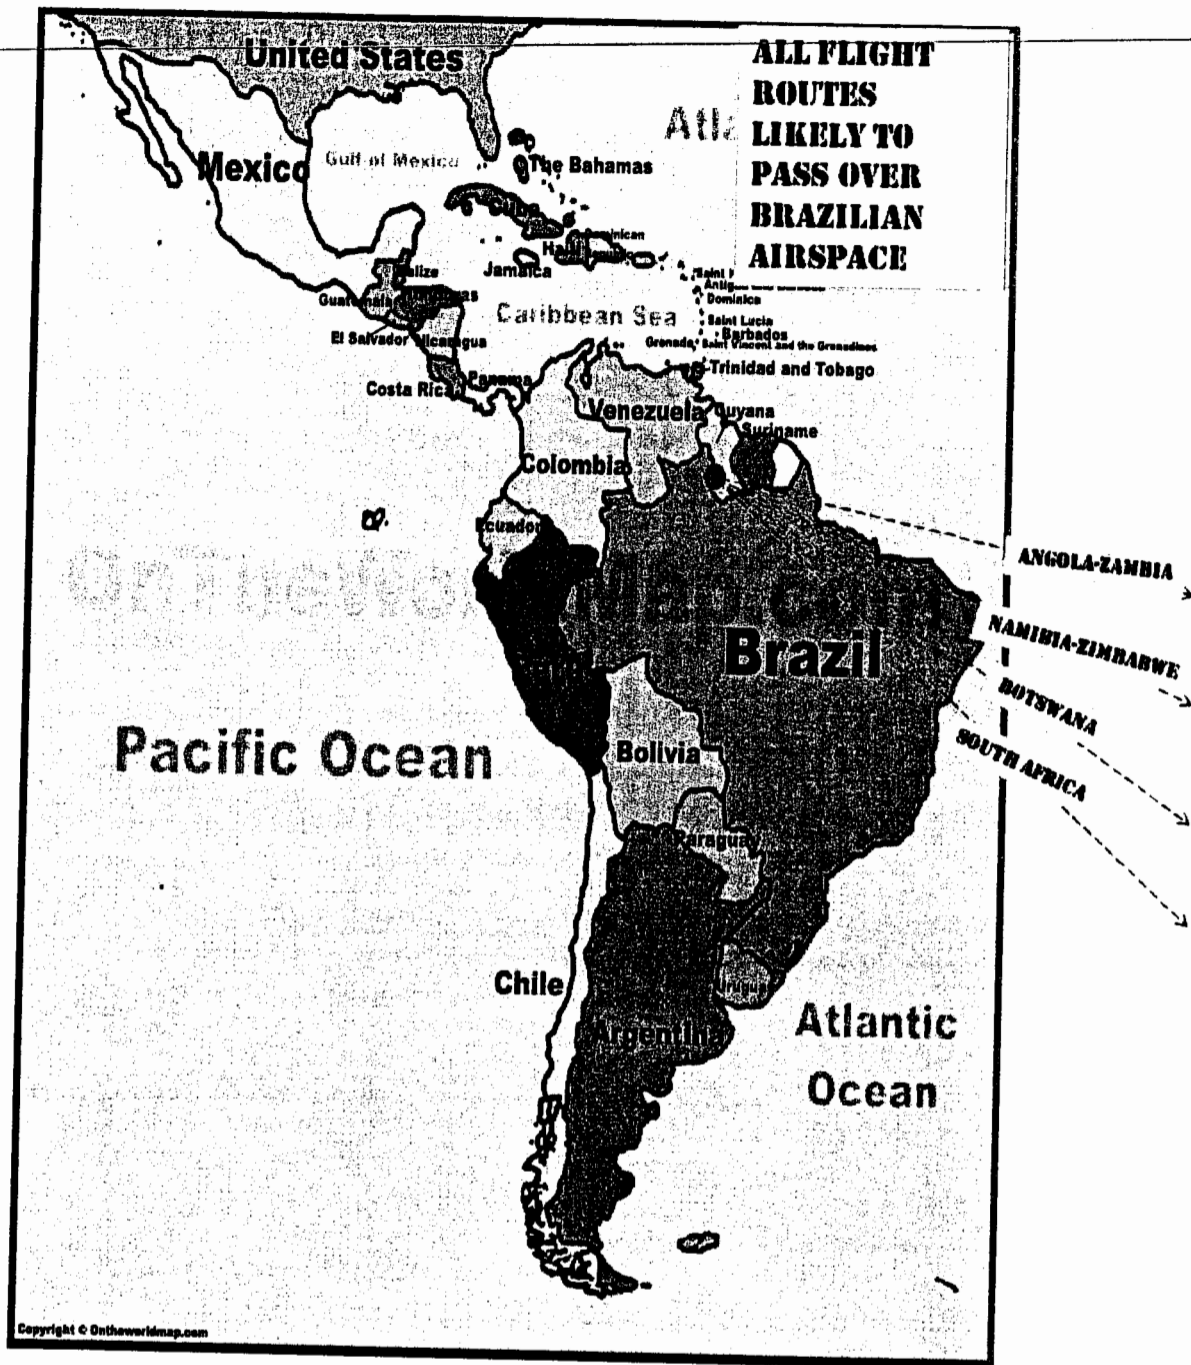
APPENDIX 5: RANGE OF AIRCRAFT

The Cessna 441 aircraft, which was discovered in Southern Guyana, is powered by a Garret Engine. In fact this aircraft has a modified engine upgraded to four blades from the original three blades. Notably this is not an inexpensive operation to upgrade as it enables the aircraft to fly higher, faster and increases the overall range of the aircraft.

b. The Commission found that this type of aircraft was developed by Cessna as a *VIP transport aircraft for executives and the moderately wealthy*. As such, it would have been "fully loaded" with the latest in avionics and a luxurious leather interior at the time of delivery to its first customer. Additionally, this aircraft was equipped with *modified engine and upgraded to four blades from the original three blades*. Notably, it is not an inexpensive operation to upgrade as it enables the aircraft to fly higher, faster and increases the overall range of the aircraft as shown in Appendix 5 – Aircraft Range

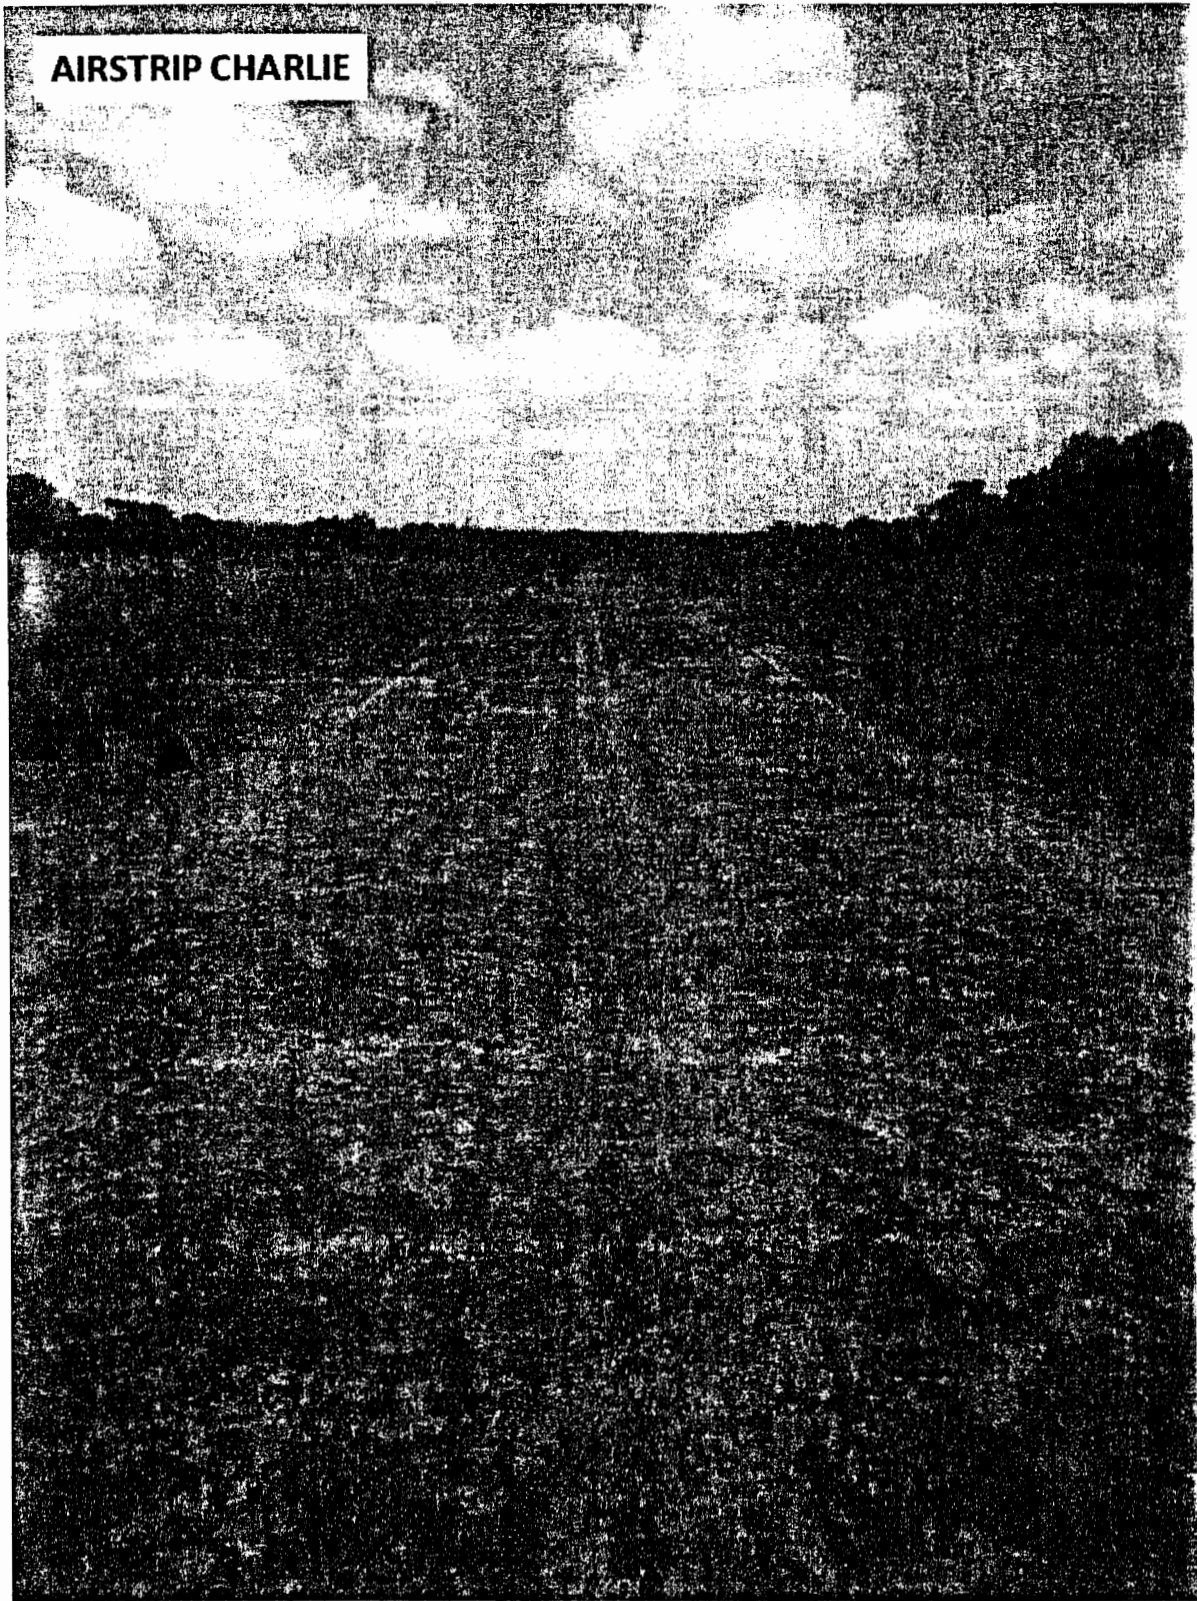
AIRSTRIP CHARLIE

AIRSTRIP SEEN ON SUNDAY 2016-10-02 1200 HOURS
ALMOST 24 HOURS AFTER THE AIRCRAFT FLEW OUT
OF LETHEM TO GEORGETOWN AND 48 HOURS
AFTER IT FLEW TO LETHEM

Note the Tire Marks. Photo Taken on
Sunday 23rd October, 2016

h. The Commission found that the aircraft safely landed on the hard-surface, wet-weather, illegal airstrip specifically built - with local help - to accommodate this type of aircraft. Unable to restart, the disabled foreign aircraft remained hidden at that location out of sight of passing local aircraft. It was also hidden from the Security Forces deployed in that Region until 14th September, 2016 when it was discovered by a joint Police-Army operation, launched the previous day for that purpose.

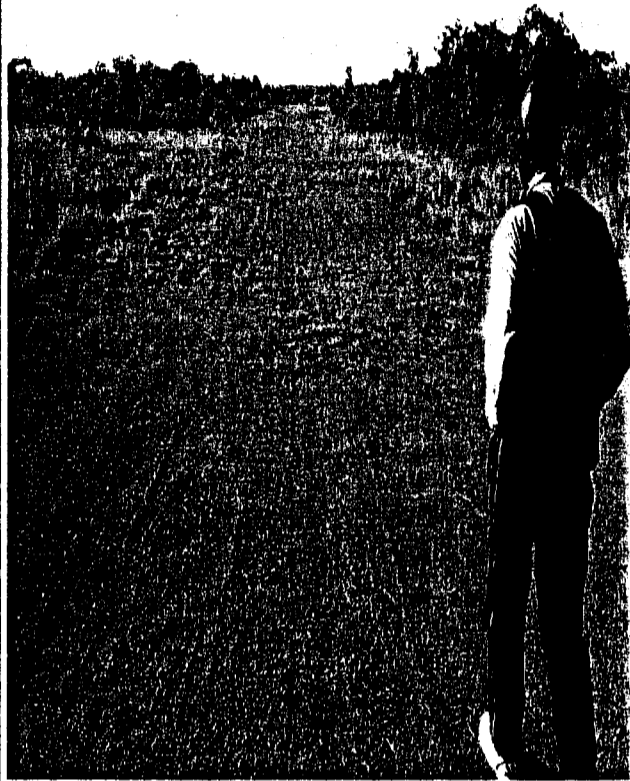
Figure 4 to Appendix 7

AIRSTRIP SEEN ON SUNDAY 23RD OCTOBER 2016 1600
HOURS; ALMOST 21 DAYS AFTER THE AIRCRAFT FLEW
OUT OF LETHEM TO GEORGETOWN AND 22 DAYS
AFTER IT FLEW TO LETHEM

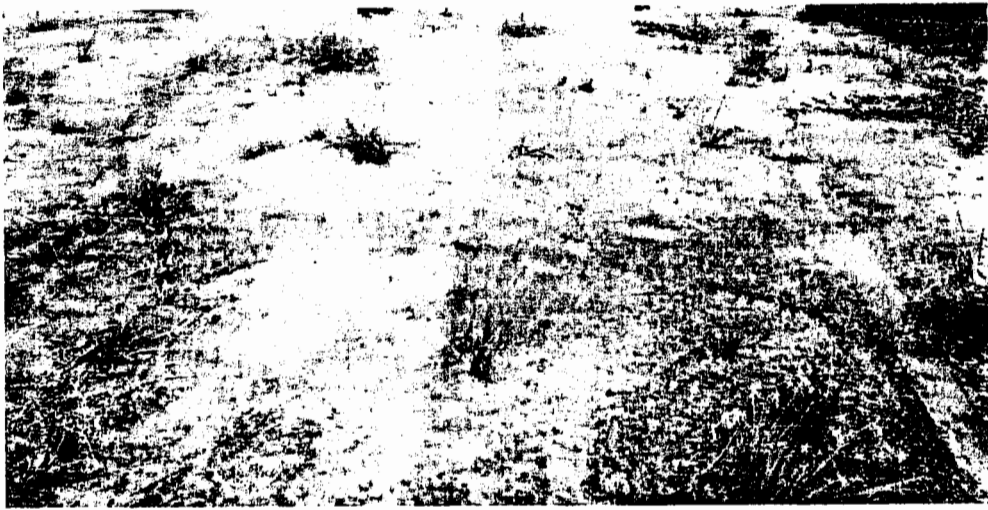
PHOTOS OF THE ILLEGAL AIRSTRIP AT MARAKANATA

From the tracks it is believed that a plane landed within that past ninety six (96) hours.

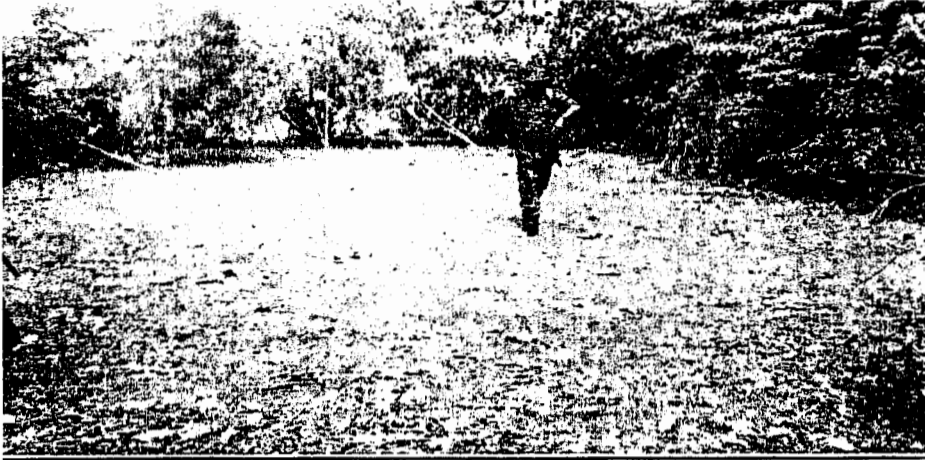
Branches are placed to the front to hide the plane in the area shown

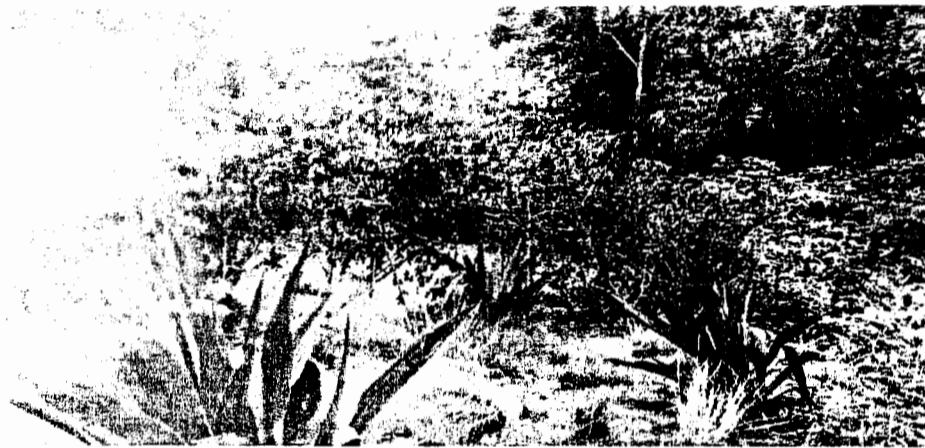
How it looks from the front, also the plants shown in the picture were dig out and placed there
